**WOODBIDGE RESEARCH FACILITY
1995 ASBESTOS SURVEY**

WOODBIDGE, VIRGINIA

FINAL REPORT

October 6, 1995

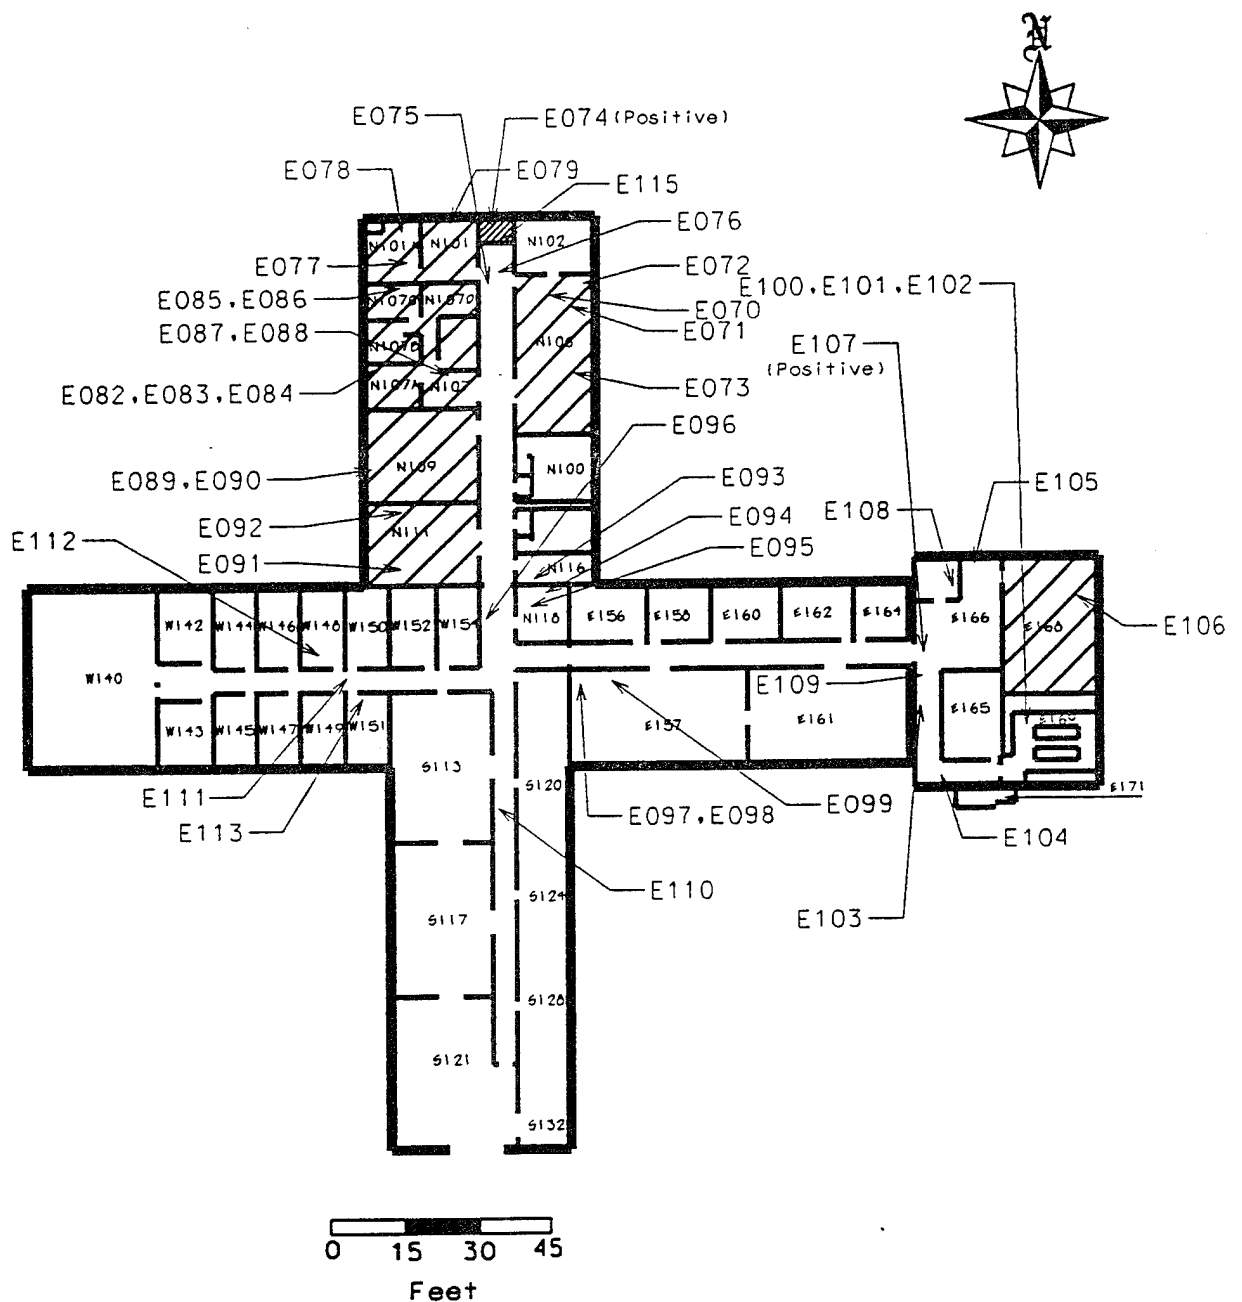
Building # 201

- Two of the forty-four samples collected from building 201 are ACM. The 12"x12" beige with white and gray mottling floor tile in the lobby of building 201, contains 5 to 10 percent chrysotile asbestos. The white glue on the duct work above the suspended ceiling in room 166 contains 5 to 15 percent chrysotile asbestos.
